**SHASTA RIVER PRELIMINARY
ENGINEERING REPORT
FOR FISH SCREENING/PASSAGE
IMPROVEMENTS**

**Great Northern Corporation
Weed, CA**

April 2002

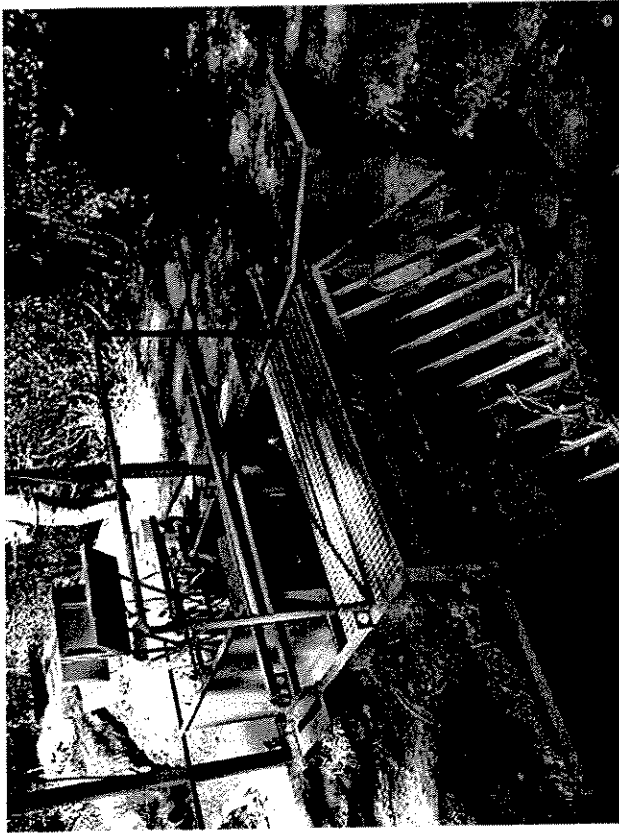
(SOURCE: Nordlund 1998)

Rotary drum screens have been widely used in the Pacific Northwest (Nordlund, 1996). These screens have had a good success rate and are widely accepted by regulatory agencies. The screens operate by powering a screened drum that rotates to move debris away from the screen. A typical installation and schematics of a rotary drum screen is shown in Figure 2.
